**DOCKTON ROAD PRESERVATION PROJECT
PHASE 1 GEOTECHNICAL REPORT
PROJECT NO. 300208
APRIL 2009**

RE: **Dockton Road Preservation Project Phase 1 Geotechnical Report**

In accordance with your request, we have completed a Phase 1 Geotechnical Report for the Dockton Road Preservation Project. The purpose of this report is to provide the baseline geologic and geomorphic setting of the project site in order to aid alternative evaluation and selection.

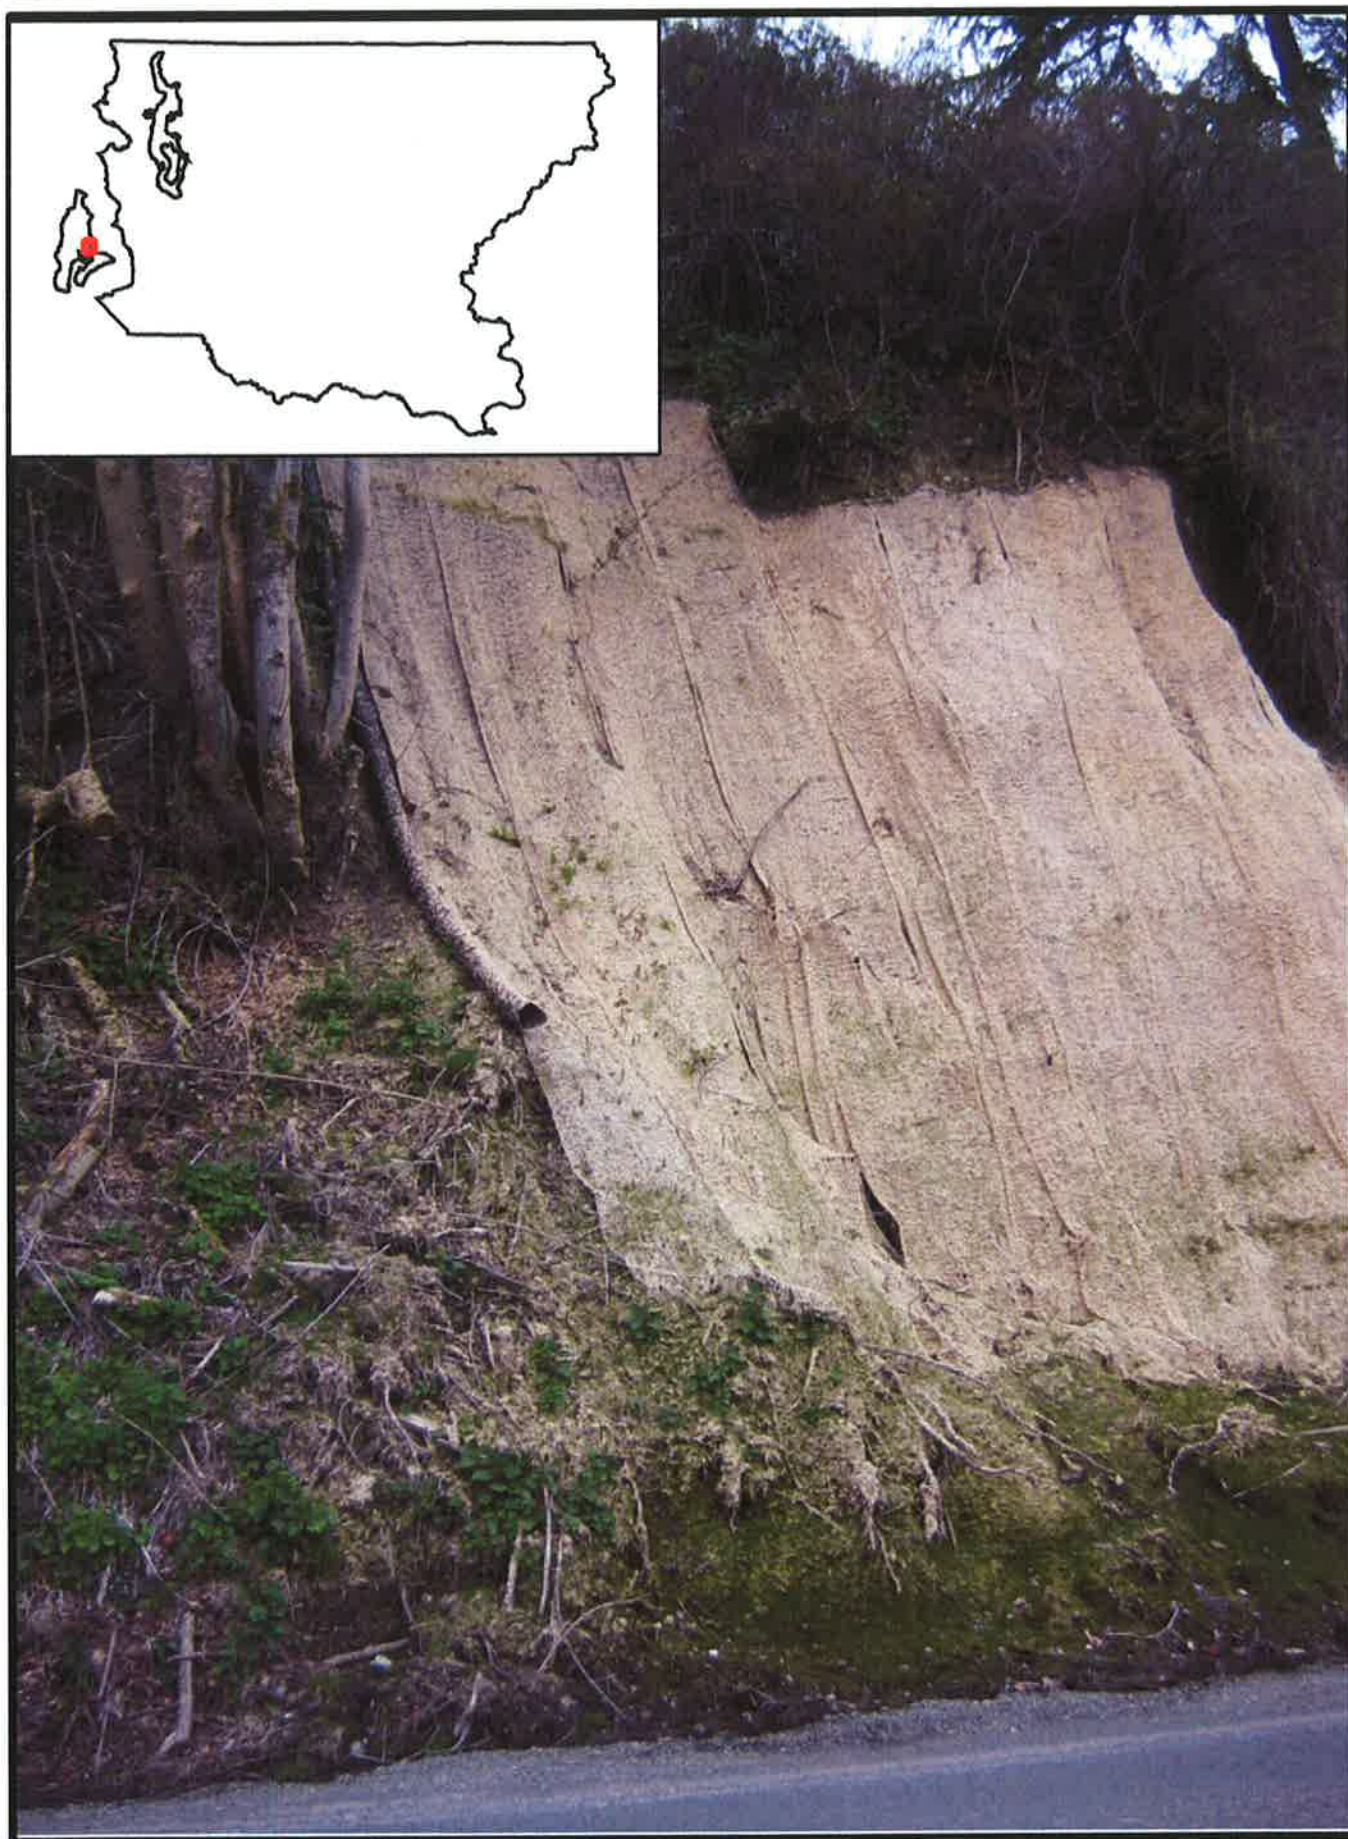
Figure 6: Drain lines from parcels extending down the slope to Dockton Road.

Two shallow landslides of the bluff occurred this past year in January of 2009 after extended periods of heavy precipitation. The cause appeared to be saturation of the oversteepened and weathered slopes with possible contributions from residential drainage. For landslide repair, King County maintenance removed sloughed soils from the toe of the slope and roadway. In addition, jute matting was placed and hydroseeded in an attempt to re-establish slope vegetation. Pictures of the two recent landslides and residential drainage discharging on steep slopes can be seen in Figures 6 and 7.
